CT-25

LETCHWORTH'S CHANCE

INVENTORY FORM FOR STATE HISTORIC SITES SURVEY

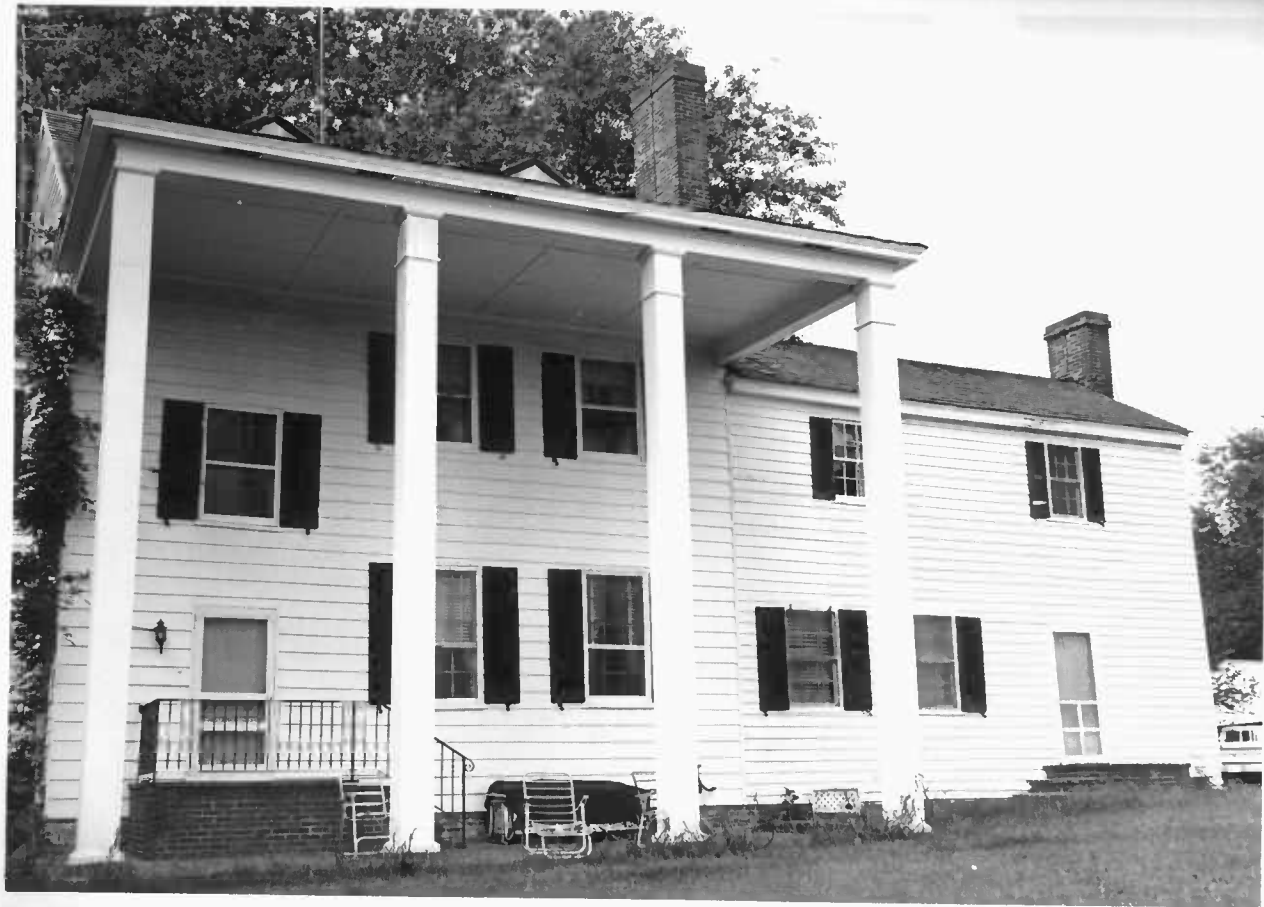
E.

The initial stage of this large, three part frame house is the two and one half story, three bay Federal main block. It has two exterior chimneys ~~at~~ at one end and a modern two story pillared porch at the principle facade. In the mid-19th. century a lower two story addition was built to the chimney end. A more recent addition stands at the opposite end of the main block.

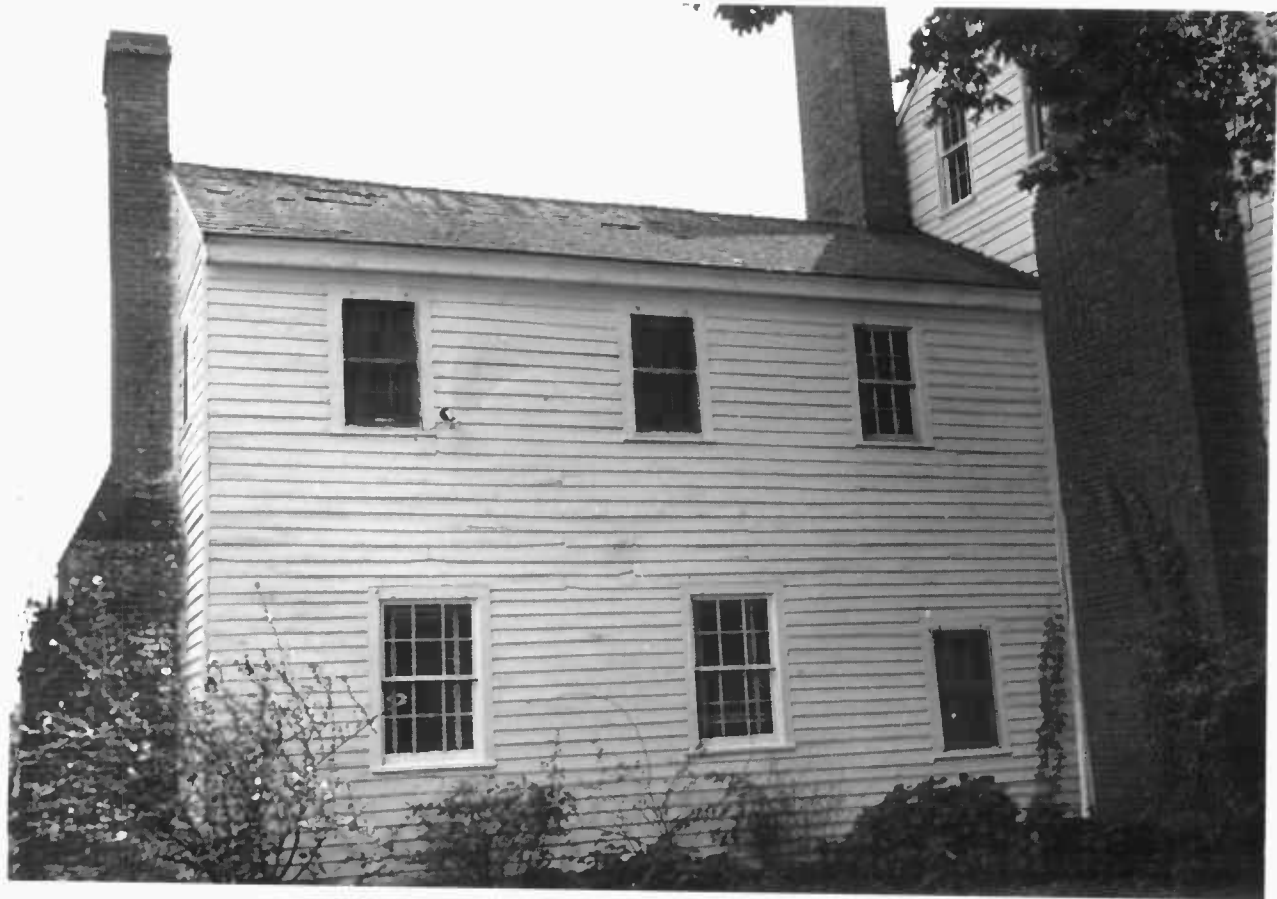
W. FACADE OF
N. END

It is presumed that the north section is the oldest portion of the house. This $1\frac{1}{2}$ story wing has one room down and one up. There is an exterior chimney on the north end that served both the main room and a semi-detached log kitchen that has been demolished. The Nield family have owned this property since the late Nineteenth Century and have discovered much in the way of archaeological finds. Mr. Bob Nield remembers that while replacing the floors in the north wing (c.1922) charred sills were found beneath indicating that even this building is not the first on the site.

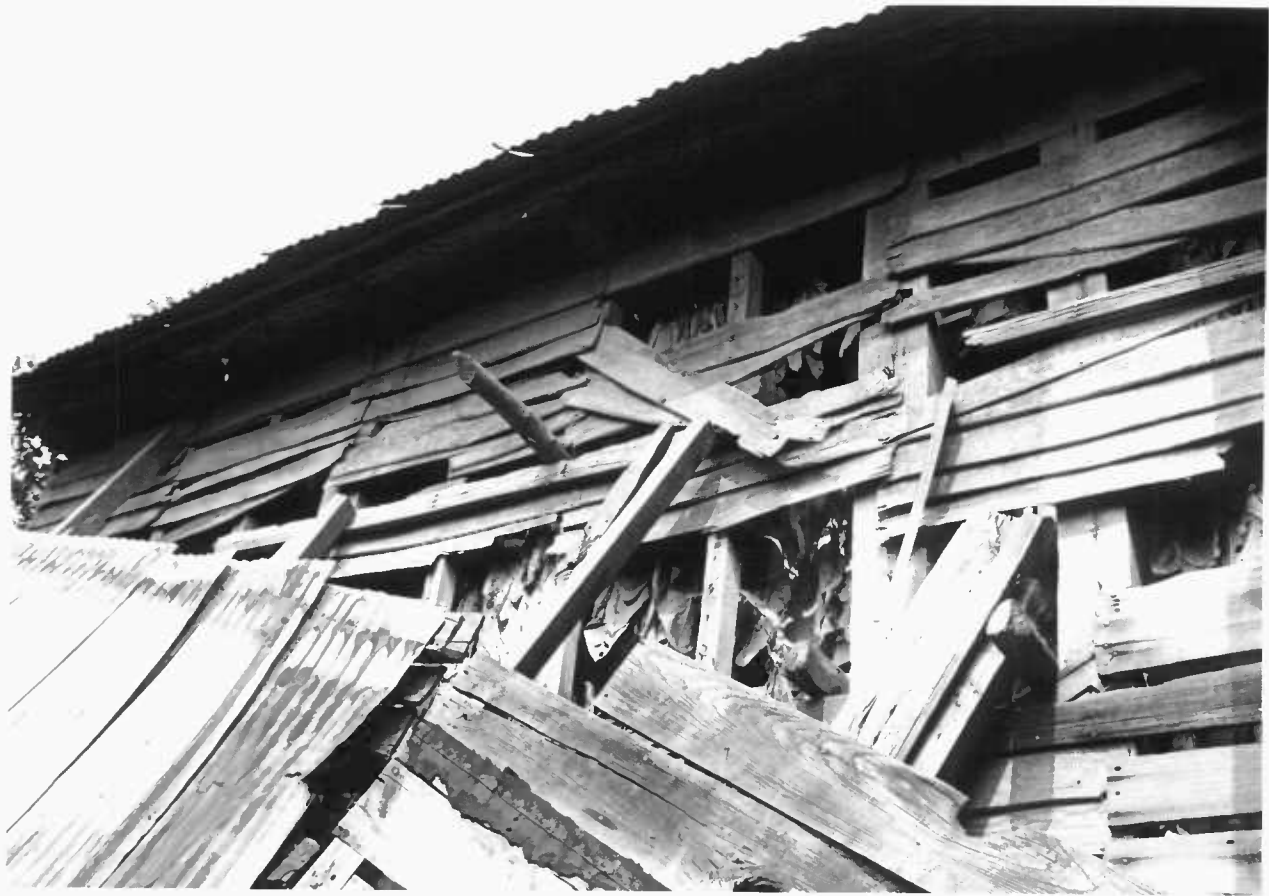
S. WALL

There are two tobacco barns on the property. Both are in poor condition and will be demolished. Barn #1 is closest to the house. It is a ten room barn with a single transverse sill. A south shed was added to house animals and until it collapsed, protected the original siding on the original south wall. Both 2' riven clapboards and 14' feather edged weatherboard were observed, both being attached with machine cut nails. Barn #2 has the same hewn post-and-beam frame as #1, however, it is a fourteen room barn with two transverse sills that establish a central passage between two bays.

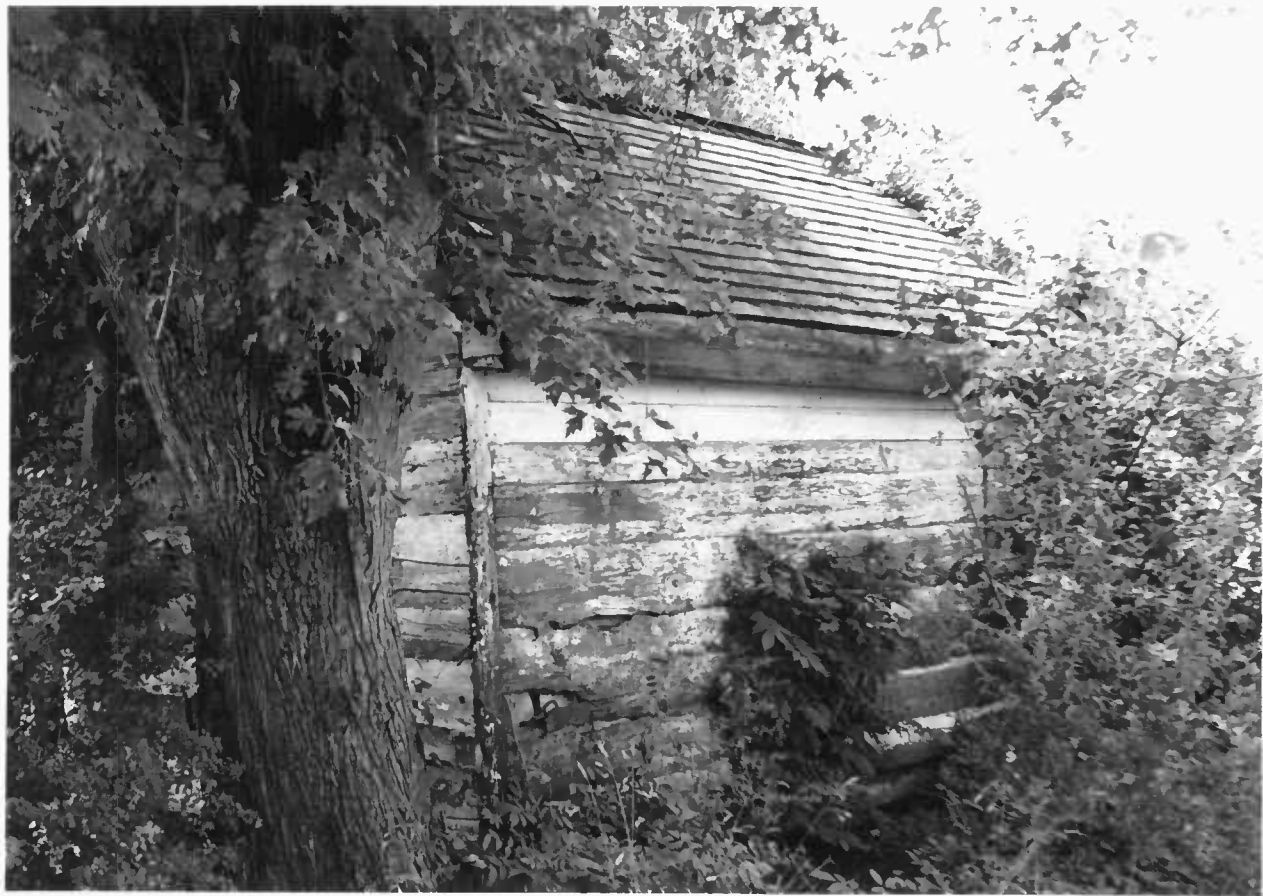
CT-25
MEAT HS
N.

There is a meathouse which, along with the dairy, stands on the south side of the property in close proximity to where the log kitchen stood. The meathouse is of log construction although the degree to which the logs have been finished might make them more properly called "planks". Each is pit sawn to measure 7" wide and 3" thick. They are

lap-notched and laid with c. 3" of space in between. They are not clinched and random width feather edge weather board was nailed to the exterior side. Some of these weatherboards remain on the north wall and measure up to 14" wide. The building measures up to 14" wide. The building measures 10'4" in depth (exterior) and 14' in length. The eaves are 6'3" above the ground.

The interior has been whitewashed, there is evidence of smoking. The tie beams are made from what are apparently reused beaded ceiling joists. (The meathouse across the road at CT-26 does too as does the one at CT-50.)
